Enclosed for your records is a copy of OSM's inspection report for the 9th East Portal Phase III Bond Release Inspection conducted on May 17, 2011.

Mine Site Evaluation

Deer Creek Mine, Energy West Mining Company
Utah Division of Oil, Gas, and Mining (DOGM) Permit No. UT-015-018
Phase II and III Bond Release Inspection

May 17, 2011

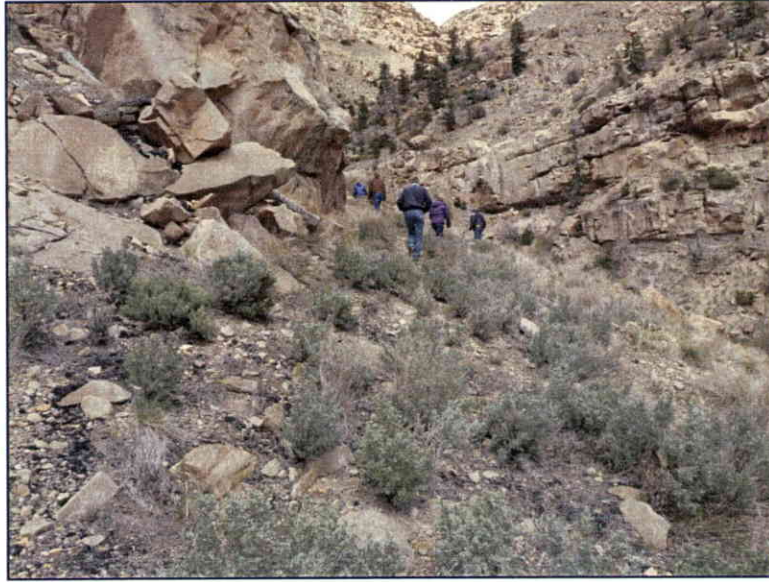
Photo 1 – Beginning of reclaimed road heading towards portals

The group began the inspection at the mine office in Huntington, Utah. Mr. Oakley and Mr. Fleck briefed us on the reclamation efforts regarding this 0.6-acre area and answered questions. We then drove to the 9th East Portal Breakout vicinity and began walking the Wilberg Mine fan road to access the bond release area (see Photo 1).

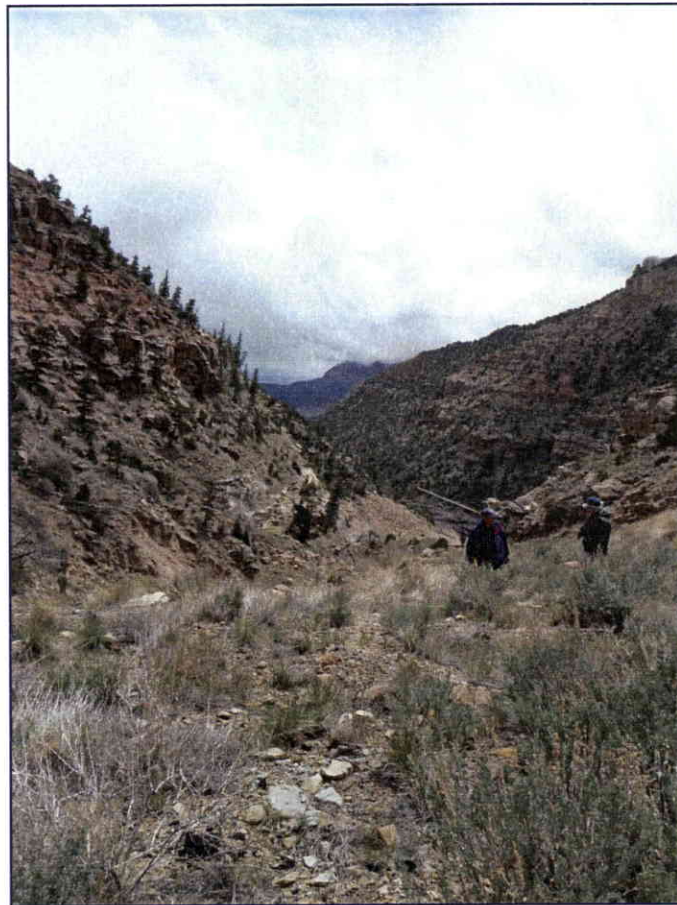
Photo 2 – At reclaimed portal area looking down-valley

The slopes were regraded to blend with the natural drainage pattern of the surrounding area. The road was backfilled using on-site material that was previously used for berms located in front of the portal area and along the access road. The road slope and portal area appeared stable (see Photo 3). There is no indication of erosion in this area (see Photo 2).

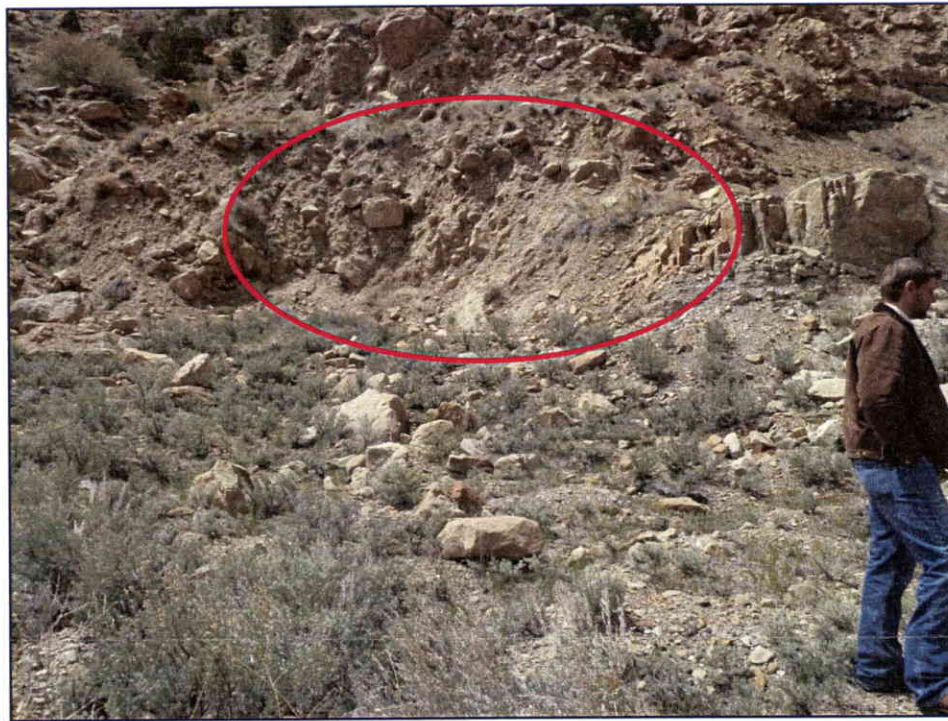
Photo 3 – An example of a reclaimed portal

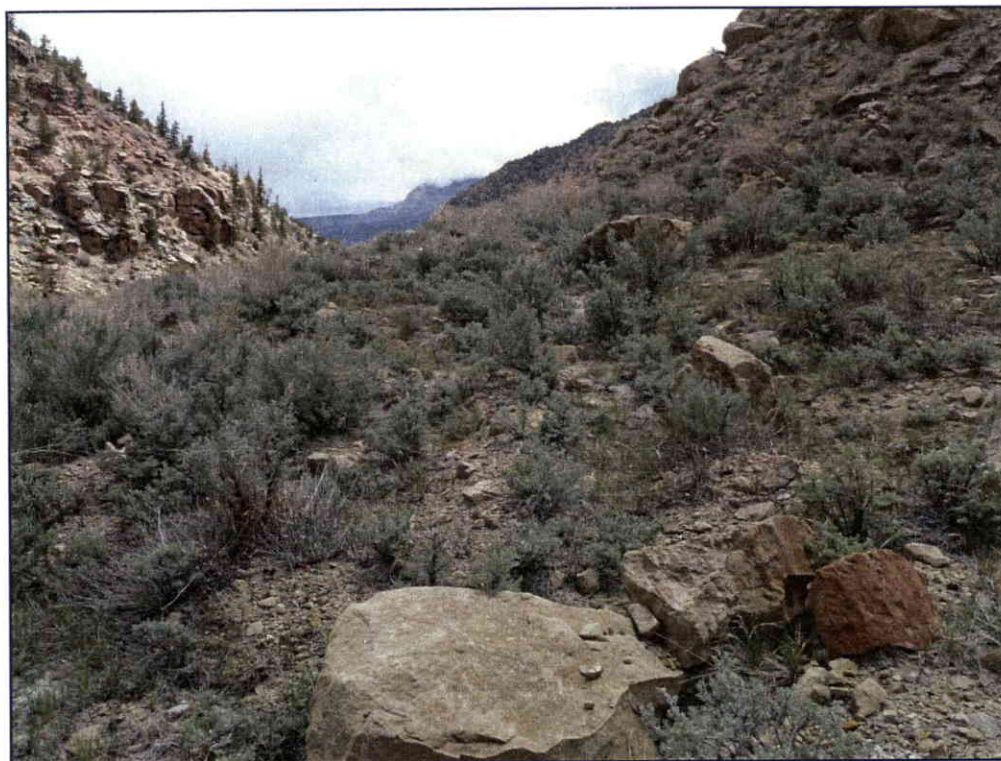
Photo 4 – Well established vegetation in reclaimed portal area

The vegetation along the reclaimed road was well established (see Photo 4). A track-hoe was used to roughen the disturbed area to create pockmarks, which were designed to capture precipitation, thus aiding infiltration and the establishment of vegetation. The exposed surfaces were initially protected by mixing the soil with hay mulch. The group identified sagebrush, Pacific aster, fourwing saltbrush, shadscale, rabbitbrush, and thickspike wheatgrass at the site. Vegetative sampling was conducted in fall of 2008 and 2009 by Mt. Nebo Scientific, Inc. of Springville, Utah. Additionally, vegetation monitoring has occurred for several years following reclamation. All vegetation complies with Utah Coal Regulations at R645-301-357 (Extended Responsibility Period).
